CC5™ Bulk Rolls

Enna Province, Sicily

CC5™ was used to cover a slope 281m in length, and 14m in height in Piazza Armerina, Sicily

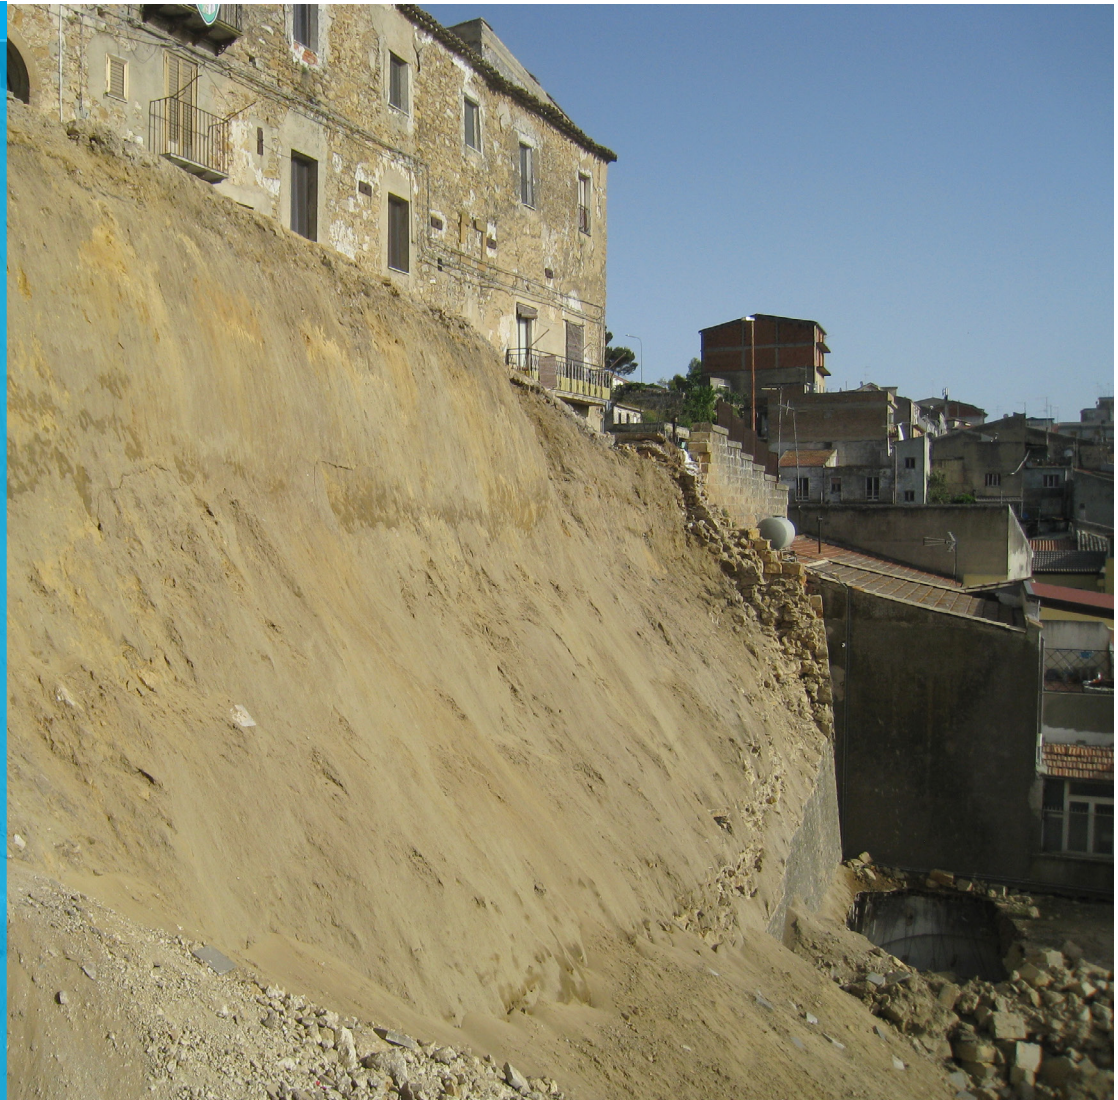
The slope prior to installation

In August 2015, Concrete Canvas® GCCM* (CC) was used to protect a steep slope in the Piazza Armerina in the Enna Province, Sicily. The slope was 281 metres in length, and 14 metres high, and had been exposed after a historical wall (built in the 1900s) collapsed, and dragged the parking areas above down with it. The slope was in need of temporary protection to prevent further collapse on the site.

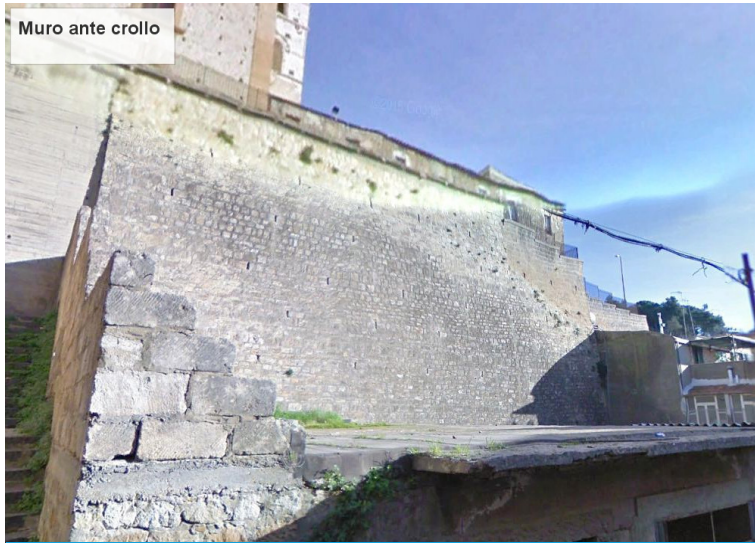
Muro ante crollo

The historical wall which previously occupied the site

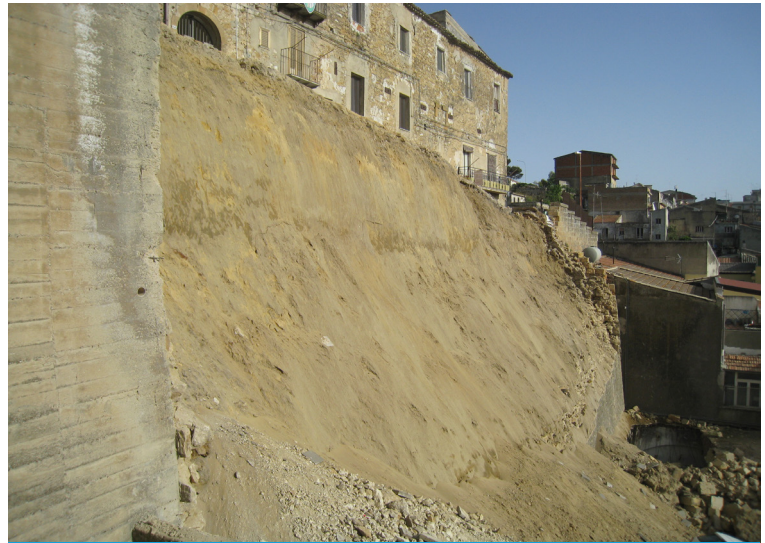
The site following the wall's collapse

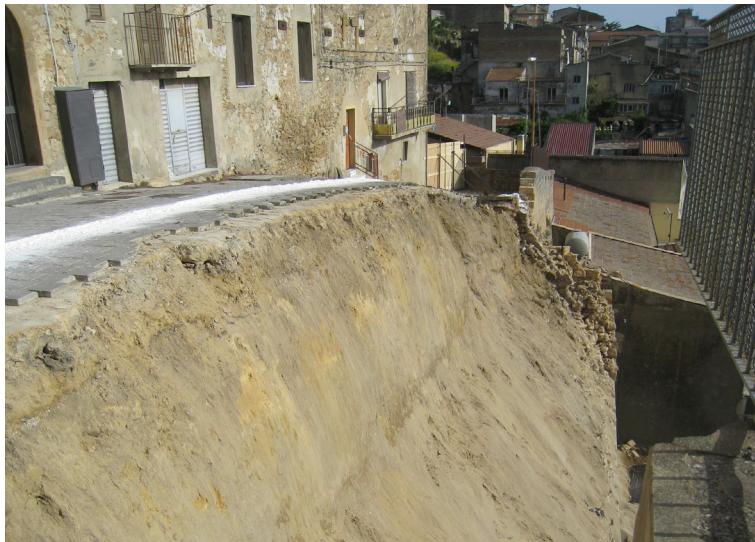
The wall's collapse also took down some of the carpark above

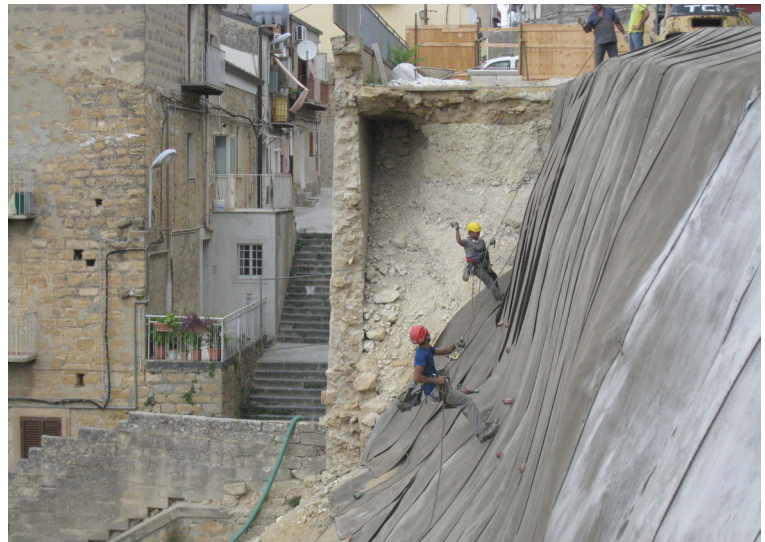
Two rock climbers assisted on the installation

400m² of CC5™ were installed over a period of four days by a team of three people, including two rock climbers, in temperatures upwards of 35°C. The Client was very happy with the ease of installation of the CC and how well it met their needs.

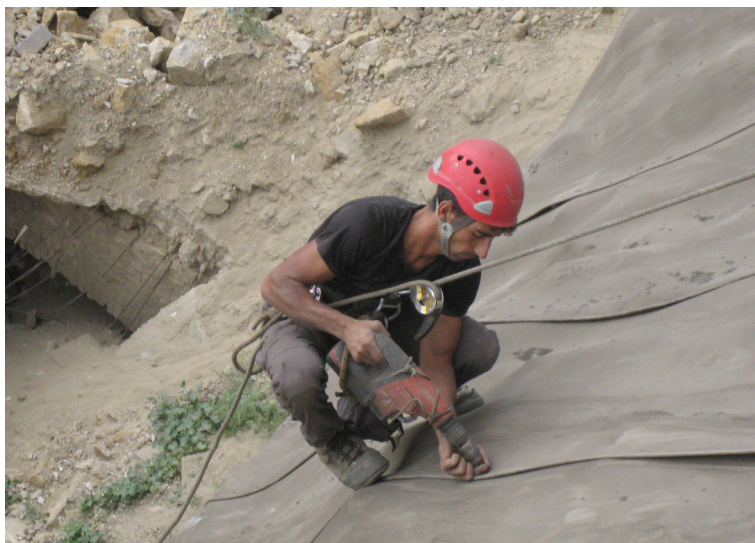
The CC was fixed with screws every 200mm

Work began with ground preparation, which consisted of the removal of any stones, rocks and moving soil parts which could disturb the CC or make its fixings less effective. The CC was then fixed with screws at intervals of 200mm, along with top anchor trenches and ground pegs every 1 metre along the top of the slope, before being hydrated with a hose.

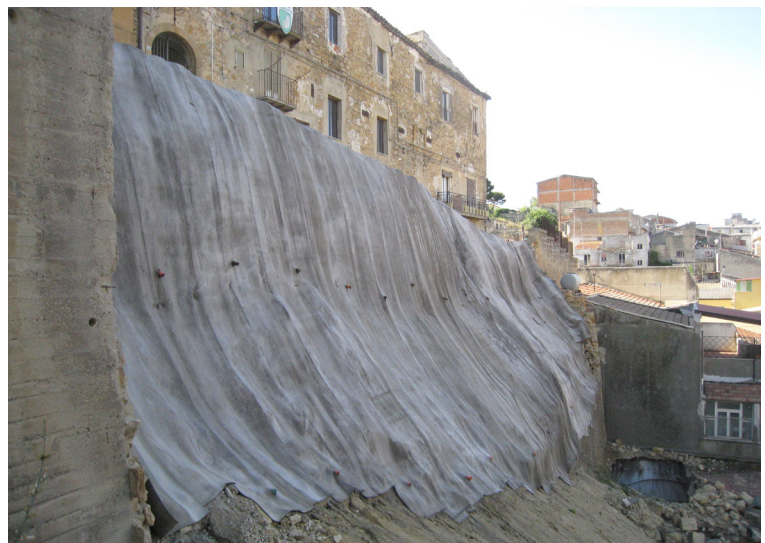
Completed installation

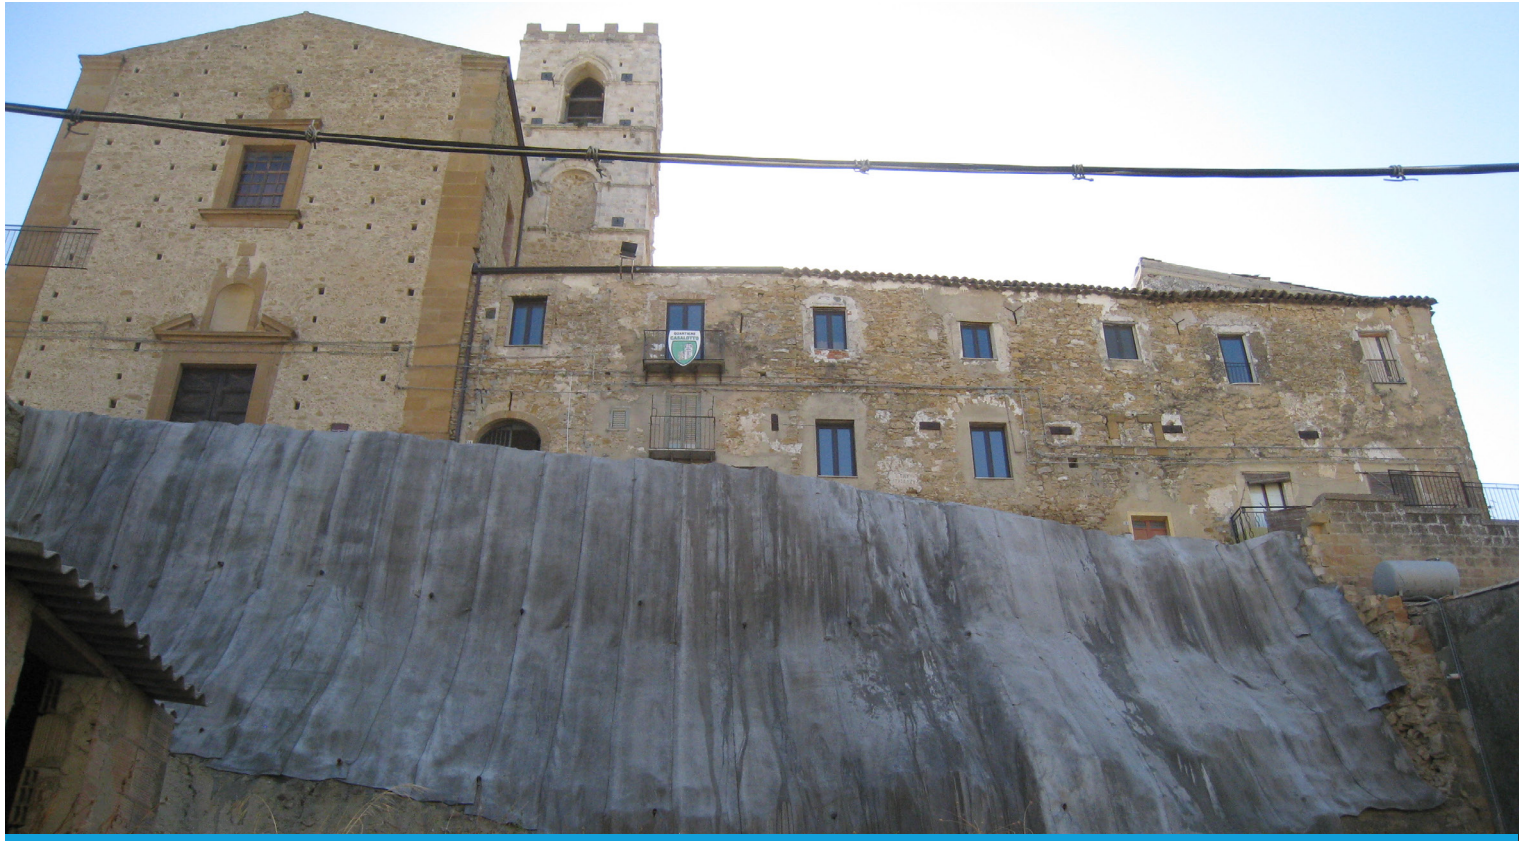
Completed installation
